Case study: Top chain 3D modelling and photogrammetry

BW Offshore, operator of the Sendje Berge FPSO, enlisted Ashtead Technology's expertise in obtaining detailed information on top chain dimensions both above and below the waterline. This information was used to determine which lengths of chain required replacement, and which could be kept in service.

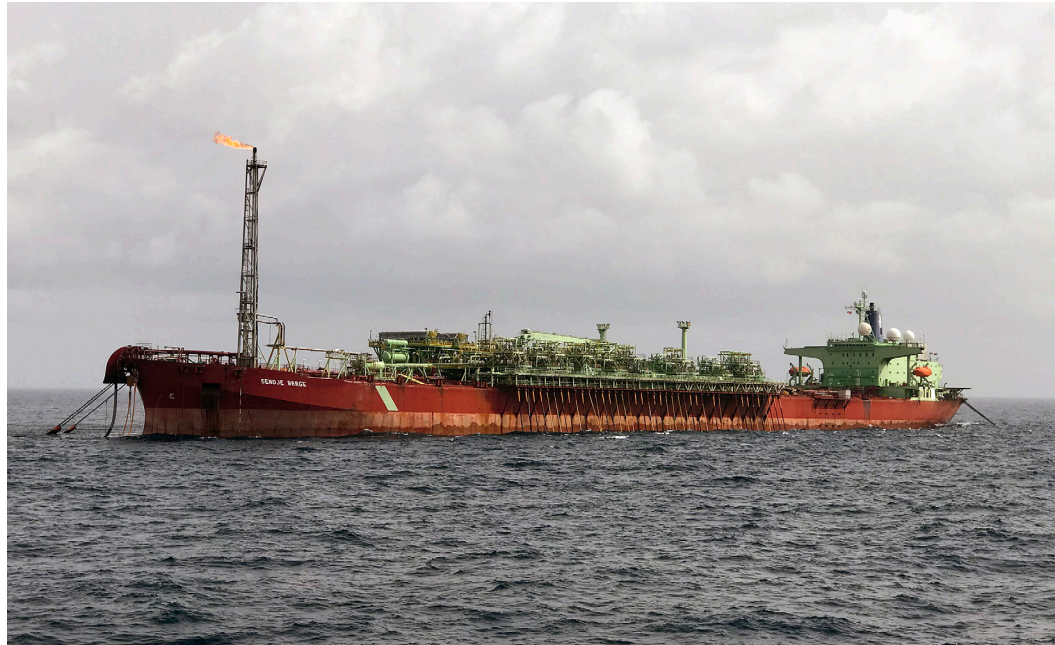
Specialist technicians from the Asset Integrity team conducted a two-phase inspection with project management for rope access technicians (RAT) topside and remotely operated vehicle (ROV) subsea operations. The most heavily-degraded links were determined by RATs using a handheld caliper and by ROV using the Subsea Caliper, with 3D models created using in-air and subsea photogrammetry systems.
